ANALYTICAL RESULTS OF SLOPE FAILURE AND EFFECTIVE USE OF FLYCAM DATA: A CASE STUDY FROM KM 11 TO KM 13 ON THE 3B HIGHWAY, BACKAN PROVINCE OF VIETNAM

Keywords: flycam, Geoslope/W, slope failure, safety factor, 3B highway

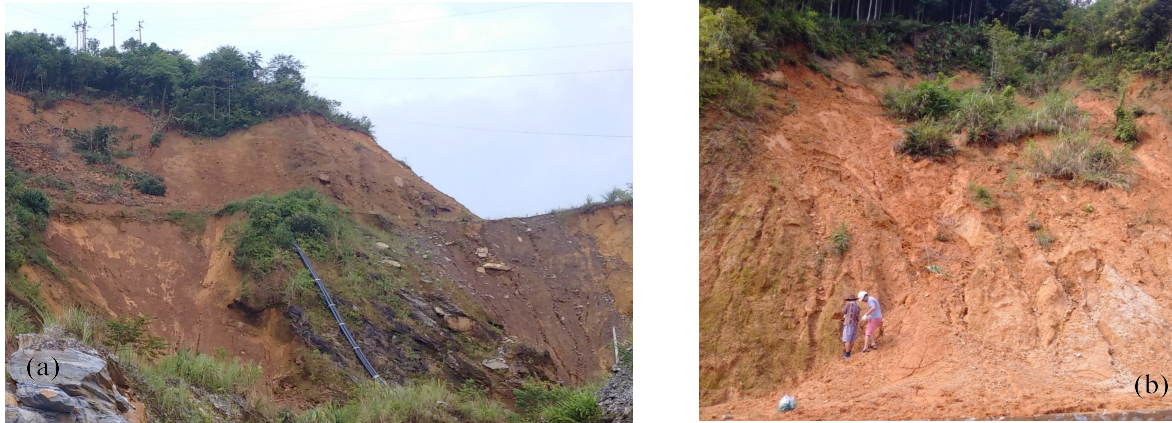
The analytical samples is used in this paper, collected at the failure site in Figure 1.

Fig.1: (a) sampling site M-05; (b) sampling site M-02

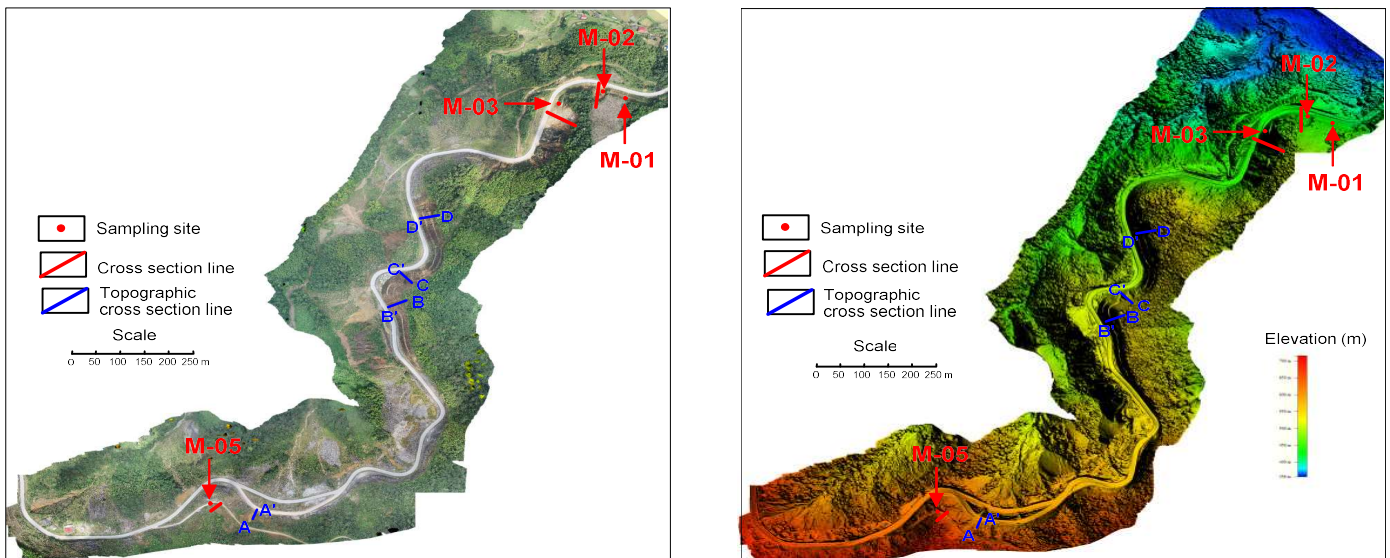
Fig.3: Photo of 3B highway, section from km 11 to km 13 belong to Backan province is taken by flycam and it's topographic 3D model

Topographic image obtained from analyzing flycam data in the study area has identified many slope failure points (5 failure points) at the elevation within 440 and 660m. The analytical results from flycam data

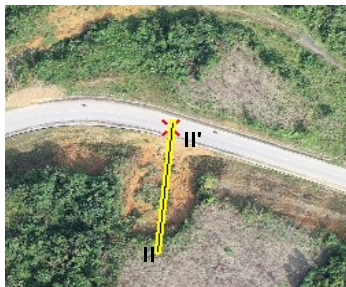
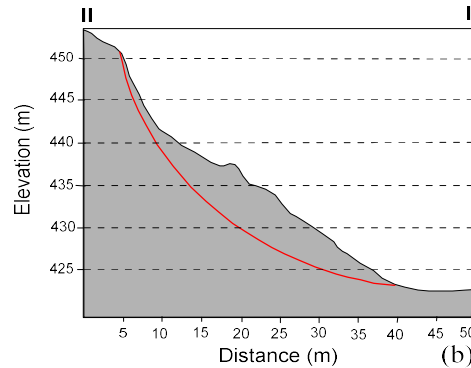
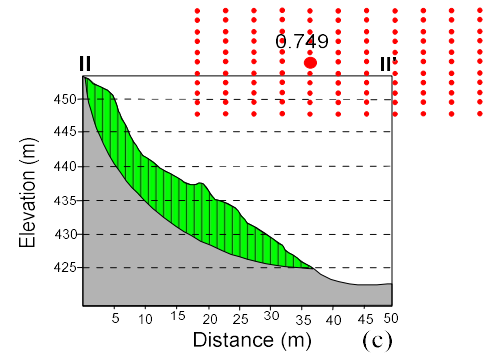
1. Circle failure at survey site M-02

No	Survey site	Internal friction angle (ϕ) (degree)	Cohesion (c) (kPa)	Unit weight (γ) kN/m ³	Factor of safety
1	M-01	11	25.5	16.5	
2	M-02	16	18.2	18.2	0.749
3	M-03	17	22.6	18.6	0.660
4	M-04	18	22.6	17.8	
5	M-05	13	30.4	18.9	0.854

Figure 4. 1) Circle failure at survey site M-02; 2) Circle failure at survey site M-03; 3) Circle failure at survey site M-05

Figure 4 presents the typical cross sections of circle failure at three survey sites: M-02, M-03 and M05. In which, a) photo of the slope failure and the cross section line which perpendicular to the slope surface; b) current cross section which is drawn from flycam data; c) predicted model of the circle failure that can occur on the slope surface which is simulated from cross section of b).

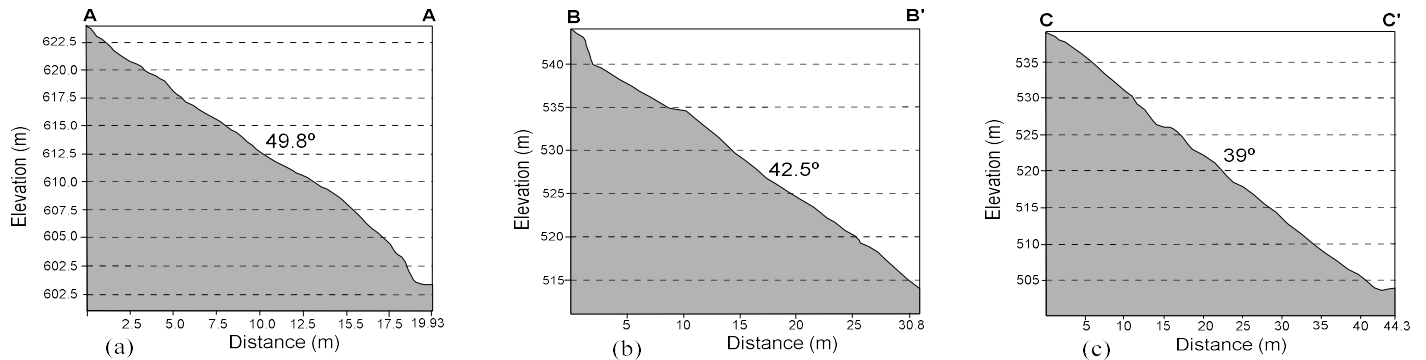
On the 3B highway in the study area, the slope surface has slope angle that varies from 40° to over 50° (Figure 5). The experimental results: Internal friction angle (ϕ), Cohesion (c), Unit weight (γ) obtained from three above samples have shown that these slope surfaces have a high risk of landslides. Similarly, the predicted failure curve at each slope surface have also determined the value of the safety factor $K_{min} = 0.867$ (Fig. 6).

Fig.5: Topographic cross section at survey sites: A-A', B-B' and C-C' which are draw from flycam data, along 3B highway, from km11 to km13, belong to Backan province (Fig. 3)

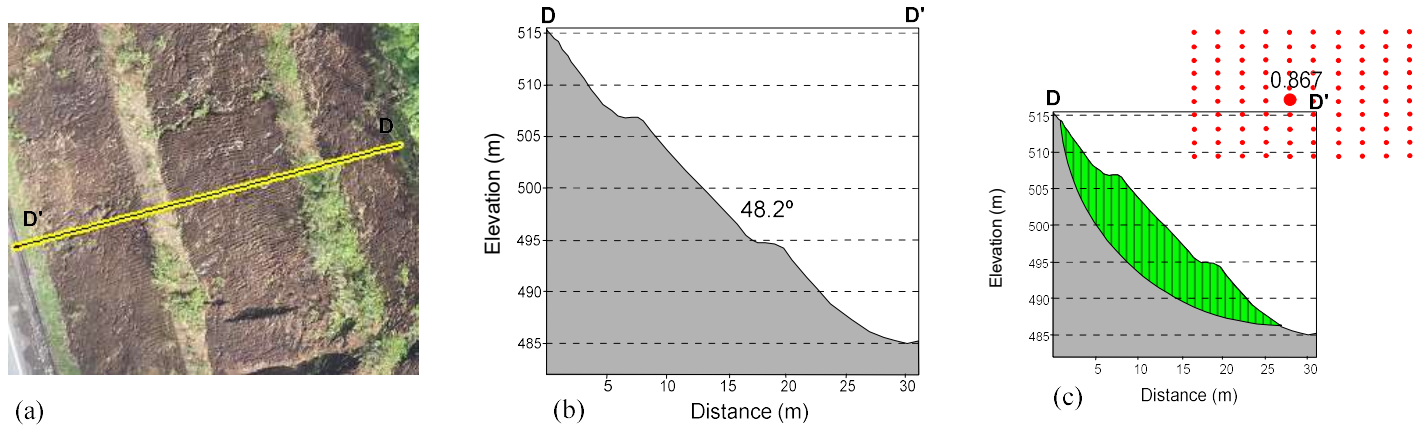
Fig.6: a) photo of the slope surface and the cross section line which perpendicular to the slope; b) current topographic cross section which is drawn from flycam data; c) predicted model of the circle failure according to internal friction angle (ϕ)= 17 (degree), cohesion (c)= 22.6 (kPa), unit weight (γ)= 18.6 (kN/m^3) that can occur on the slope surface is simulated from the cross section of b).
