Analysis Instability of the Riverbank: A Case Study of Tien Riverbank in Cai Be district, Tien Giang Province, Vietnam

Tien riverbank in Cai Be district, Tien Giang province has quite a complex geological structure and human activities, so the riverbanks are frequently instability. The article refers to the instability of the Tien riverbank flowing through Cai Be district, Tien Giang Province. Based on the collected documents, analyzing remote sensing images, and field investigations, two types of riverbank instability with varying severity were identified. The main causes of instability are river flow erosion, influence of waves, geological factors, hydraulic pressure, sand depletion, and human activities. The selection of countermeasures against riverbank erosion in the study area should consider the soft soil ground structure along the riverbank, and the impact of horizontal waves caused by boat activities. Regarding the countermeasures for stability of riverbank, the method of pre-stressed piles exhibit a good solution against riverbank erosion. The research results are the basis for proposing effective prevention solutions to serve sustainable development along this river.

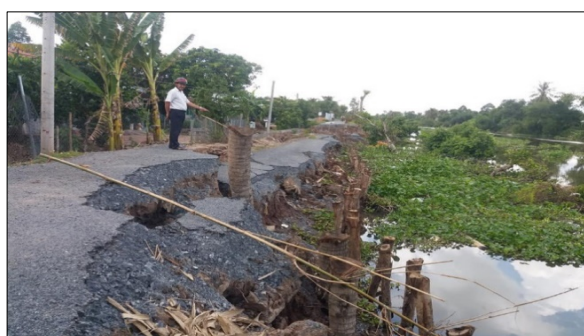
For instance, in 2020, the riverbank erosion in Hau Thanh commune, Cai Be district (Figs. 7, 8, and 9), affecting the lives and travel of local people. Along canal No. 07, in Hau Vinh hamlet, Hau Thanh commune, Cai Be district, the dike was destroyed more than 60m long and 3m wide. Although this incident did not cause any loss of life, but the dike which is a key traffic route in this area was cut off; many houses along the dike are unsafe. The Tien River sections have complex terrain, so riverbank is a high risk of erosion. According to the detailed planning, this area will be used to built the infrastructure for a commercial and service area connecting to the Tien River.

Fig.7. "Frog jaw" landslide point in Hau Thanh commune, Cai Be district (2020)

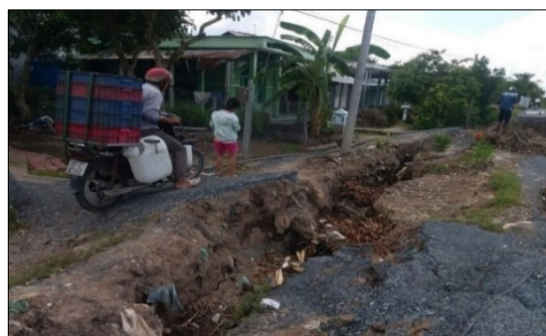
Fig. 8. People's travel and goods transportation face difficulties (2020)

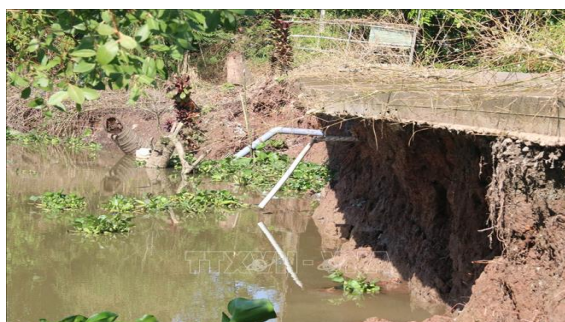
Fig. 9. Landslide creating a cleft deep into roadbed 54C (2022)

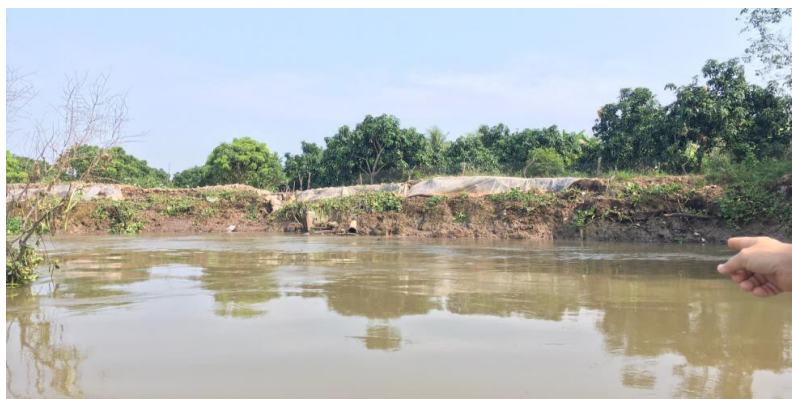
The general morphology of the river section in Cai Be area is that of a curved river section in the delta, divided into many creeks, with many floating islands, and is in the process of complex evolution. Therefore, this river section is unstable and the sedimentation and erosion are manifestations of the natural process of change and interaction between the flow and the channel. According to the law of flow, in the curved river section, the process of bank destruction occurs on the concave bank and accretion on the convex bank (Fig.10).

Fig. 10. The riverbank erosion in a curved river section in Cai Be District (2020)

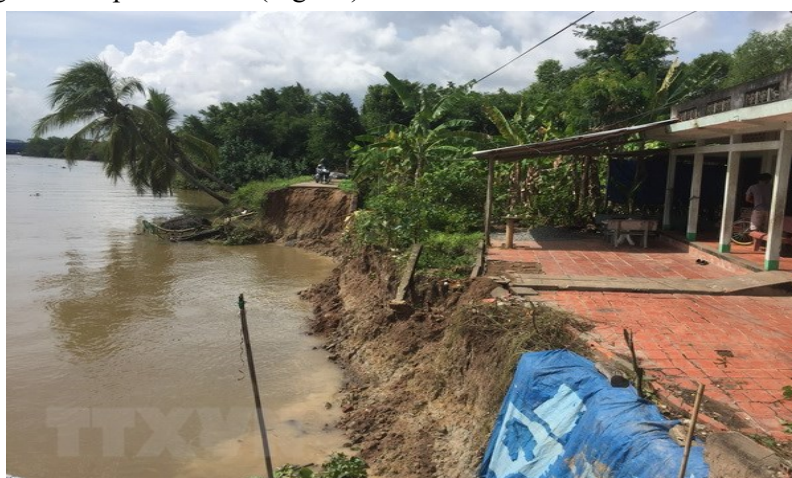
A typical landslide along the banks of Cai Be canal in Dong Hoa Hiep commune, Cai Be district, occurred at the end of June 2017, with a length of 32 m, reaching dozens of meters deep inland, causing a section of road to be lost, threatening the safety of life and property of two households in An Thanh hamlet, and Dong Hoa Hiep commune (Fig. 11).

Fig. 11. The riverbank erosion in My Duc Dong, Cai Be District (2021)

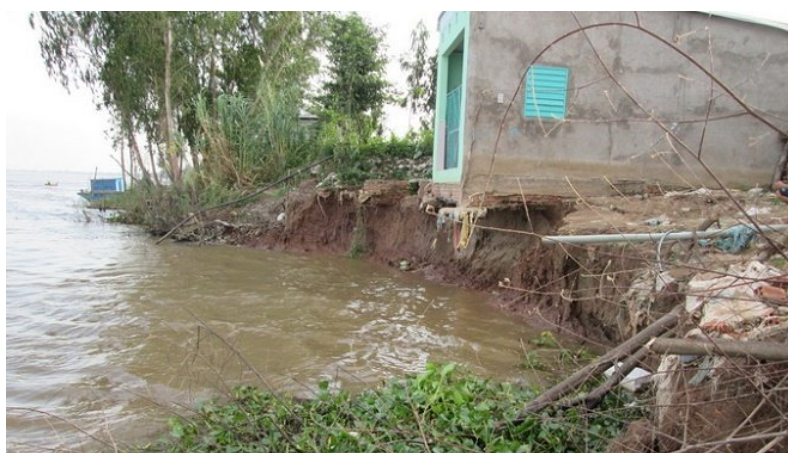
Fig.12. The riverbank erosion caused by boat activities (2021)

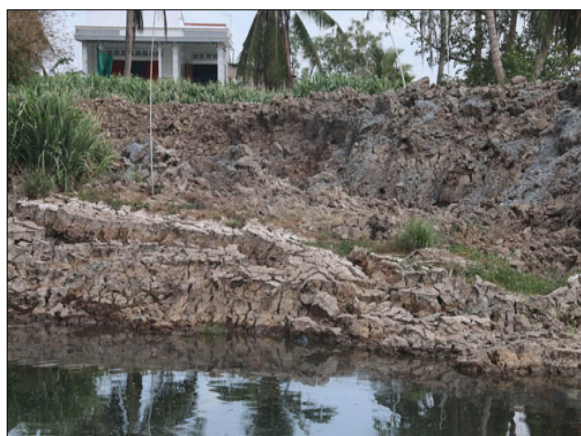
The study area's soil has a soft soil (Table 1), the riverbank has a high height and steep, so the riverbank is very susceptible to erosion and landslides and cannot withstand the load in coastal areas. Therefore, if there are no structural measures to control the impact, this area is at very high risk of bank erosion due to coastal load, threatening the lives and property of the state and people in the future. The river banks composed of soft clay, dust and sand layers will be susceptible to erosion, causing instability of the riverbank, especially in conditions of changes in flow.

Fig.14. Canal bank erosion due to weak geology (2020)

In addition, due to weak geological conditions, the construction of riverbank and riverside protection works here needs to be carefully researched to improve the design condition so that it is stable after construction or right during the process of construction. Landslides still occur during the construction process. Even if the lifespan of these structures is significantly reduced, it is necessary to have solutions for calculations that are close to reality and suitable for the weak soil conditions here.

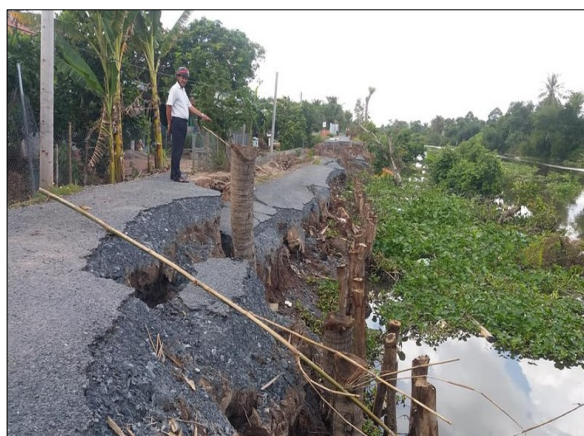
Fig.15. The riverbank erosion in Hau Thanh commune, Cai Be district (2020)

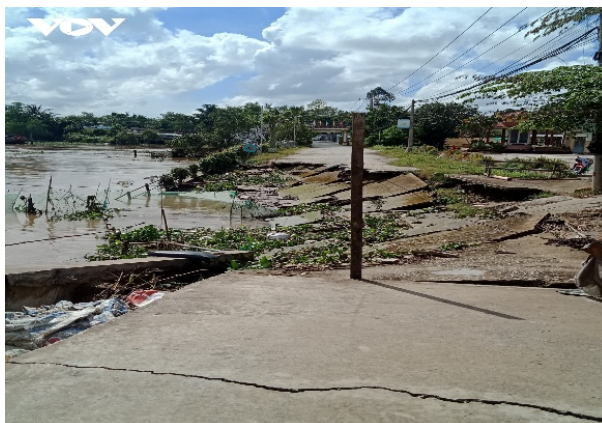
Fig.16. Some landslide recovery works in Tien Giang completed in a short time have subsided.

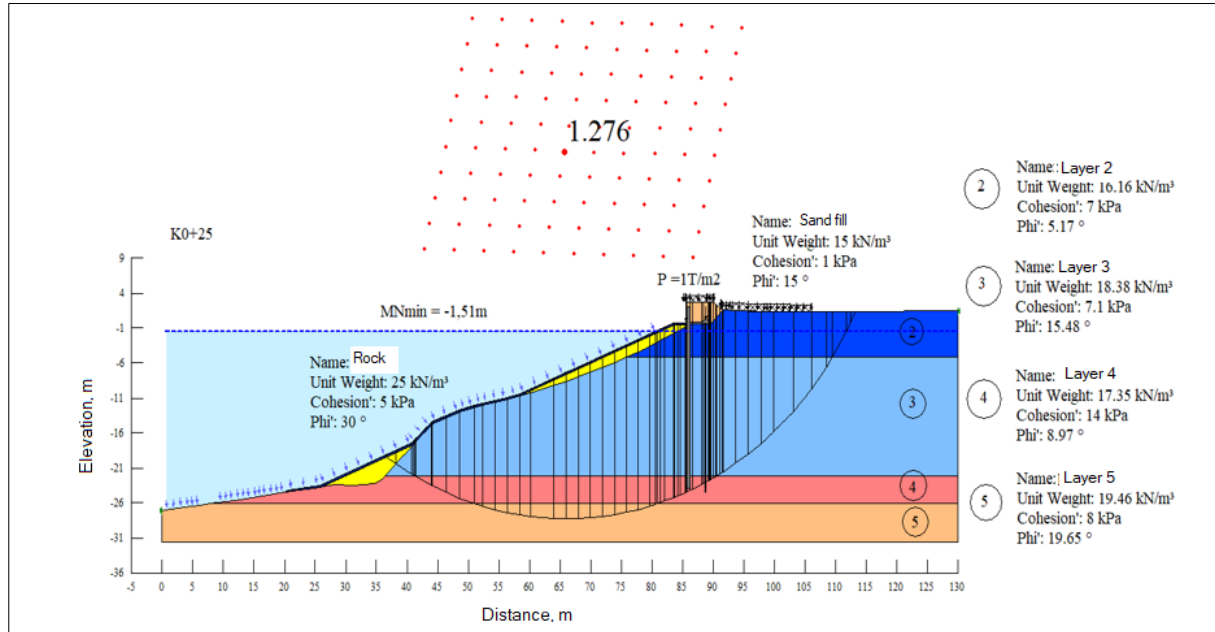
Fig. 21. Calculation results at section K0+25

assumed as a cylindrical arc, the sliding block was divided into many different pieces and the coefficient of stability (FOS) was calculated by equal to the ratio between anti-slip force and sliding force. If $FOS = 1$, the slope is in limit equilibrium, $FOS > 1$, the slope is stable and $FOS < 1$, the slope is unstable. The input parameters for the soil layers are shown in Table 1. The stability coefficient of the embankment is shown in figure 21 and 22. The results show that the embankment is stable.
