Slope failure cause evaluation based on earthworks management and meteorological conditions analyses

Conference Paper · August 2024

T.Q. Nguyen

D.B. Van, M.V. Nguyen, N.A. Do

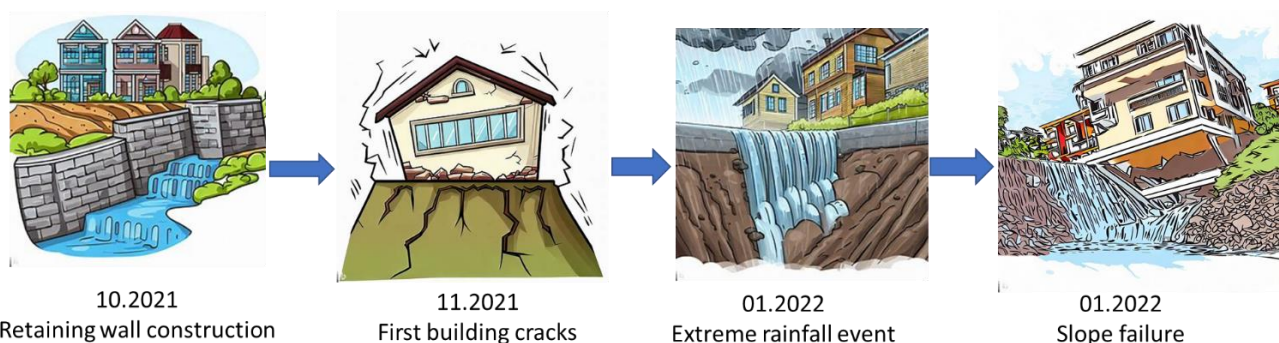
The case study concerns a natural slope with extensive infrastructure developed at the top edge. The infrastructure development started with the construction of a local road near the edge and the design of the drainage system redirecting the runoff down the 25m high slope. Following the road construction number of storey buildings were constructed in the section between the road and the slope's edge. At the toe of the slope, there is a natural stream passing with the flow changing depending on the rainfall volume. In recent years, the local community's major awareness has been focused on the erosion effect due to the stream continuously cutting the toe of the slope. Thus, a retaining wall was constructed to control the water erosion and improve the slope's stability. After the works were accomplished significant rainfall events took place. The finger pipe drainage was installed at the back of the wall. A few weeks later the residents reported the first building cracking, which continued to develop until the next severe rainfall event that was followed by the slope failure and a collapse of buildings located at the study site. Figure 2 presents graphically the sequence of events leading to a final slope failure. The authors of the present paper aim to investigate events and the processes contributing to the failure occurrence. Based on the data collected from the site investigation report, meteorological report and the information gathered during the site visits, the analytical study was performed to reflect the in-situ conditions.

Figure 2. Graphical presentation of the sequence of events leading to a structural failure of residential buildings.

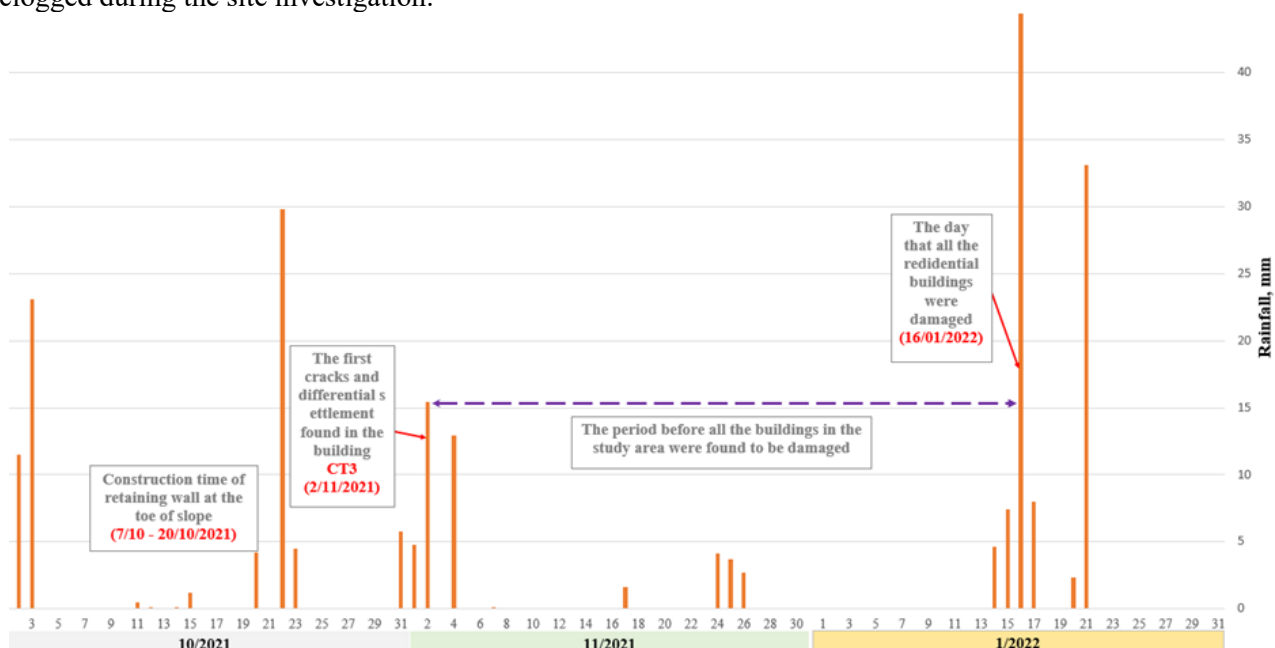
Since the rainfall events in the study were concerned with having a major effect on the failure, the precipitation data were also analysed. To allow further understanding of the failure cause the rainfall data was collected from the nearby monitoring station. Important for the study is the accumulative rainfall of 2000 mm recorded on 10.2021. Another crucial note for the study is that the finger pie drainage behind the retaining wall was found to be clogged during the site investigation.

The authors attempted first to reflect the sequence of events by analysing all the circumstances at the site starting with matching the recorded rainfall data with the time of constructing the retaining wall, through observed cracks on the buildings and the time of the final failure of the slope. The graph presented in Figure 3, shows the chronologic sequence of events to give a better understanding of all the possible causes of the final failure of the slope, which eventually resulted in severe damage to the residential buildings. In late 2021, due to the alarming technical condition of the slope, the local authorities decided to support the toe by constructing the retaining wall, in the form of a concrete gravity wall, preventing potential failure. The excavation works that took place on 7-20.10.2021 caused heavy ground vibrations that were reported by the local citizens occupying the buildings located at the top of the slope. Soon after the retaining wall works were completed a significant rainfall event was recorded, reaching 30 mm on 22.10.2021. It is worth noting that the accumulation rainfall recorded for October is 2000 mm. A week later, the first cracks developing in the buildings were observed. It was only 2 months later, on 16.01.2022 when more damages to the building were reported and the slope failed after the rainfall event that reached nearly 45 mm in a single day. Through the analytical approach and detailed investigation of events, it is assumed that two major factors triggering the slope failure were the retaining wall earthworks and poor drainage conditions during the torrential precipitation.

Figure 3. The sequence of events leading to a final failure with referencing rainfall data recorded in the study area.

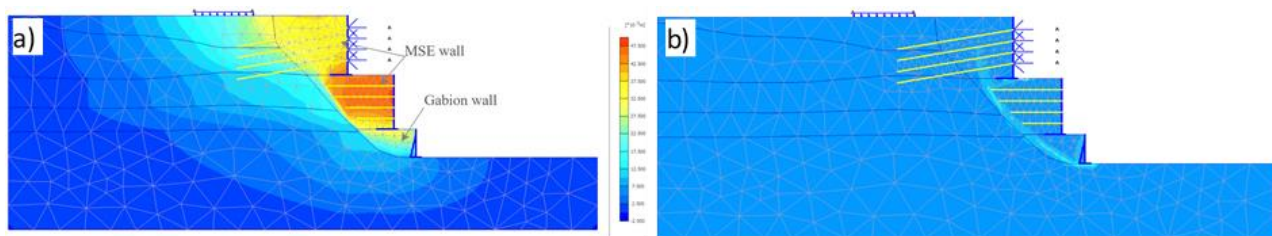
During the earthworks, the dynamic loads loosened the soil material at the building foundation. The following rainfall could then easily penetrate the soil profile causing the decrease of the soil's mechanical parameters due to build-up of effective stress, also caused by poor drainage conditions. Based on geotechnical investigation data and rainfall volume the computations of geotechnical safety were performed to determine the failure mechanism and to reflect the sequence of the events. Based on the analyses the restoration works and computations of geotechnical safety were performed. The slope stability analyses were performed using the finite element method for the parameters obtained from the site investigation. The geotechnical model used for further analyses was based on the Mohr-Coulomb

Figure 4. Computations of geotechnical safety a) displacements, b) FS and slip surface determination.

soil model, and the factor of safety was computed based on the shear strength reduction method. There were different scenarios for the analyses applied, depending on the changing groundwater level due to rainfall and infiltration. To ensure safety the entire slope was re-engineered and reinforcement such as MSE and gabion wall was proposed. The system allowed for minimising the excavation and earthworks' impact on the remaining infrastructure so as not to cause any more damage. Finding the optimum solution, the deformations and the factor of safety were computed as presented in Figure 4. The obtained factor of safety was $1.34 > [FS]=1.25$ and maximum horizontal displacement did not exceed $4.25 \text{ cm} < [\delta]=H/200 = 7.5 \text{ cm}$, where H is the total height of the wall.
