CAUSES OF LANDSLIDE IN THE ONG TUONG HILL AREA, HOA BINH CITY AND TREATMENT SOLUTIONS

Duong Van Binh¹, Bui Truong Son¹, Pham Thi Ngoc Ha¹, Nguyen Minh Hien²

Abstract: The headquarters of the Provincial Party Committee and the People's Committee of Hoa Binh Province are built at the foot of Ong Tuong hill. During the construction process, the construction unit has dug into the hillside to create the construction site and build the retaining wall system. Climate change and the status of exploitation and deforestation of tropical forests in order to make flood situation more serious. During the rainy season in 2017, especially from September to October, Hoa Binh area had heavy rain for a long time, making the soil saturated with water, increasing its gravity, reducing the cohesion and slide resistance, leading to the landslide. In Hoa Binh city, landslide occurred in three areas: East of Ong Tuong Hill, Thai Binh Ward and Cham Mat Ward. We analyzed the survey data and test results to determine the cause of landslide in Ong Tuong hill. From the current situation and the causes of the landslide, we have proposed the treatment solutions for sliding mass.

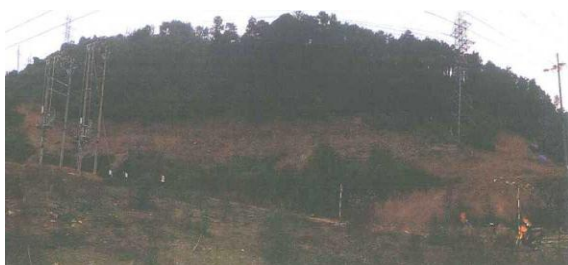
Fig. 2. Deluvi zone

1. Ban Diet formation ($C-P_2bd$)
2. Vien Nam Formation (T_1vn)
3. Dong Giao Formation:
 - Lower sub-formation (T_2adg_1)
 - Upper sub-formation (T_2adg_2)
4. Song Boi formation:
 - Lower sub-formation (T_{2-3sb_1})
 - Upper sub-formation (T_{2-3sb_2})
5. Quaternary Formations (a,e,d,pQ_1v), Fig 2,3.

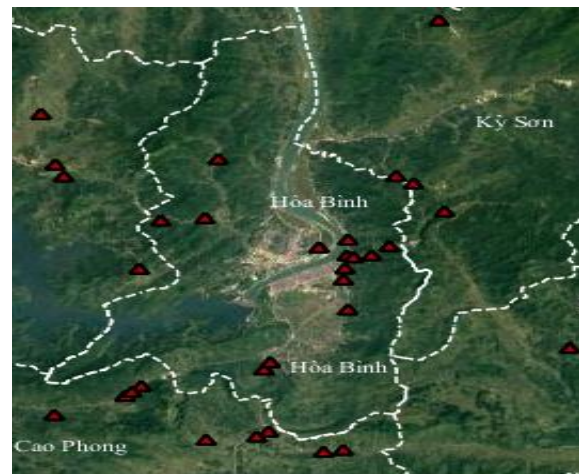
Fig. 5. Landslide points in Hoa Binh

Field survey has identified 8 land slide points, including 2 large-scale points; 4 points of medium scale and 2 points of small scale. Land slide points occur in the talus of the roads or talus after the construction or houses, Fig 5,6, Table 1.

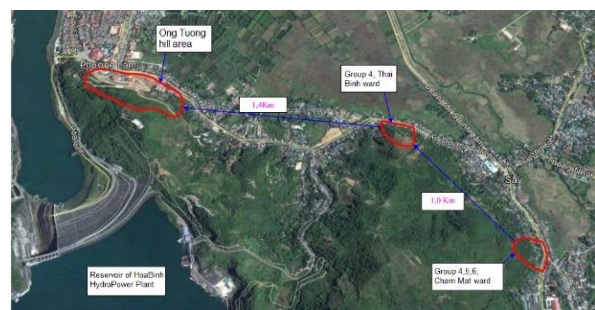
Fig. 6. Landslide points in Hoa Binh city

From the above table, we notice that landslides mainly occur in artificial slopes, near residential areas. Landslide are mainly due to human activities such as digging slopes to make roads and other structures.

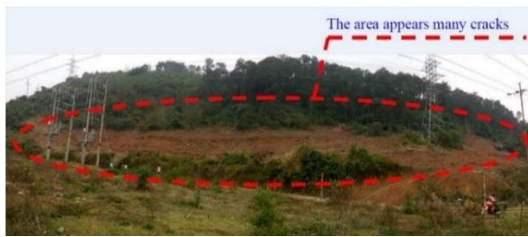
Headquarters area of Hoa Binh People's Committee is located on the east side of Ong Tuong Hill. After heavy rains for a long time, on the night of October 9, 2017, there were 18 cracks on slopes of 2 to 15 cm in width and 10 to 90 meters in length; At the same time, a sliding surface of over 300 m in length, 200 m in width, 30 m in depth is formed. The sliding mass is estimated at 1.8 million m^3 has been moved downward with a displacement of 5 to 80 cm, Fig 7-10.

Fig. 7. The status of landslide area in the east of Ong Tuong hill

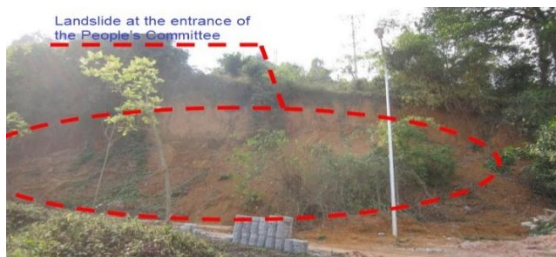
Fig. 8. Landslide at the entrance of the People's Committee

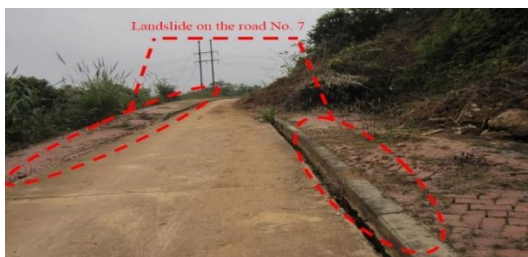
Fig. 9. Cracks on road 7 behind the substation

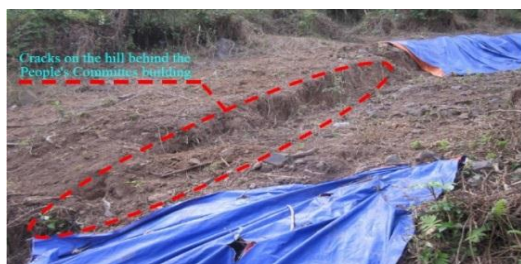
Fig. 10. Cracks on the hill behind the People's Committee building
