Large soil-cement column technique for urban underground projects in Vietnam

This paper presents an application of the large soil-cement column in Hochiminh Metro Line 1 (HCM MRT Line 1), Vietnam where a variety of jet-grout treatments were performed to protect a historical building and to ensure the tunneling process in safe.

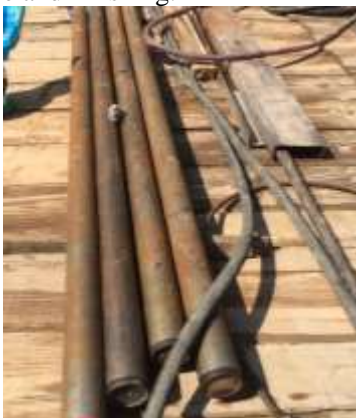
Fig.1. Jet grouting triple type rod used in HCM MRT Line 1

In jet-grouting development, manufactures have attempted to improve the performance of the jet grouting process, for example minimizing the curvature of curved parts of the fluid conduit and improving the working of nozzles from a single to a double and, then, to a triple system. Figure 1 shows a triple rod system in jet grouting. By this, soil remoulding and cementation are divided into two processes. Firstly, a high-velocity water jet is used to separate the soil through a nozzle on the upper part of the rod. Then, the water-cement grout is injected from a lower nozzle in order to cement the remoulded soil. Recently, with the development of technology, the jet grouting can reach extremely large diameters of the columns by using powerful pumps and efficient supply system. An example is a well-known "SuperJet" which can have a 5m diameter of jet grouting column (Yoshida et al. 1996). In Vietnam, a company, namely as FECON Underground Construction Jsc. in a co-operation with Raito Kogyo

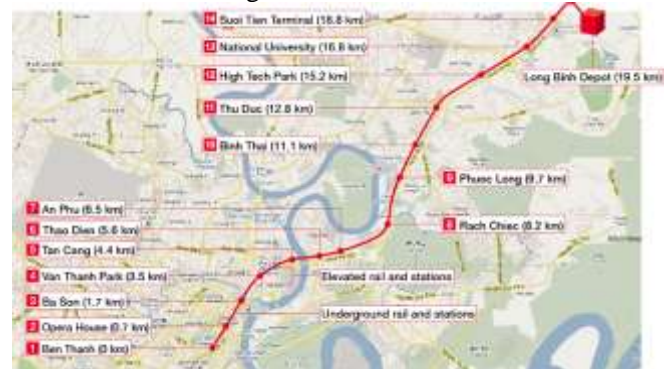
Fig. 3. A plan view of Hochiminh Metroline 1 project

underground pass the Ba Son shipyard and the Opera House, crossing the Saigon River (Figure 3). Within this corridor, the tunneling project might impact adjacent existing structures and buried infrastructure utilities (Le, H. Q., & Hsiung, B. C. B.,2014). The soil condition of the tunnel includes Fill, Alluvium and Diluvium materials. The surface Fill layer has a depth of about 2 m. The next around 30 m Alluvium layer includes Soft Clayey Silt layer, Silty Fine Sand Layer 1 and Sand layer 2. Diluvium clayey silt and silty sand layers are in deeper depths. Large soil-cement column technique was applied in this project in order to prevent damages in tunneling excavation and also existing buildings. In this paper, two case studies are presented for the application of LSCC. The first is the soil improvement for protecting at the Opera House and the second is at launching and arrival areas of the TBM.
