Numerical modeling of slope stability incorporating complex reinforcement solution in high-risk failure area- unusual case study

Ngoc Anh Pham ¹, Piotr Osinski ^{2,*}, Ngoc Anh Do ¹, Eugeniusz Koda ², Manh Van Nguyen ¹, Duc Van Bui ¹, Ngan Van Tao ³

¹ Faculty of Civil Engineering, Hanoi University of Mining and Geology, Vietnam

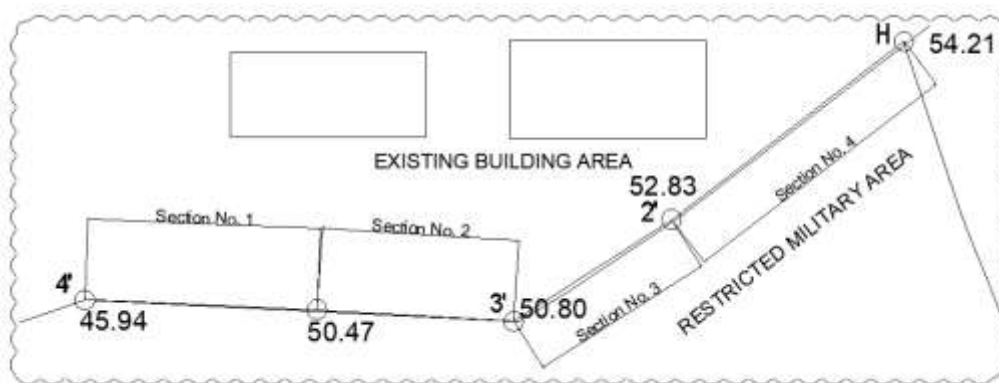
Figure 1. Aerial view of the study site.

- Section No. 1: from the elevation of 45.94 (point 4') to the level of 50.47;
- Section No. 2: from a point of level of 50.47 to 50.80 (point 3');
- Section No. 3: from a point of level of 50.80 to 52.83 (point 2');
- Section No. 4: from a point of level of 52.83 to 54.21 (point H);

The design level of the toe of slope was +35.00. The sections and location are presented in Figure 1.

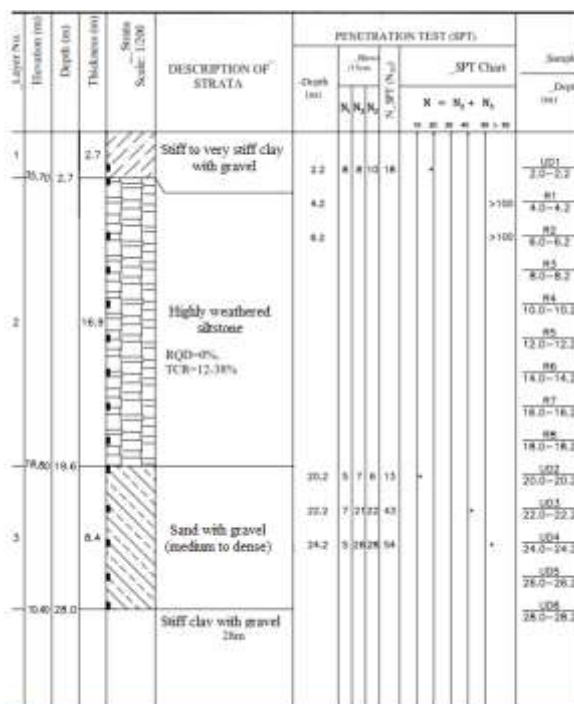
Figure 2. Example of the study site borehole profile.

4 major geotechnical layers from the top were stiff clay (down to 12 m), weathered limestone (6 m thickness), extensive (14 m thickness) medium sand (dense), finishing with deposits of stiff clay with gravel layer. Details

Since the moisture content in this particular is changing frequently due to heavy rain frequent events, the content of the small particles could lead to a displacement or even slope failure. Surprisingly, there was no groundwater table found in all boreholes nearby the hill slope. The example of a soil profile for the study area is presented in Figure 2.

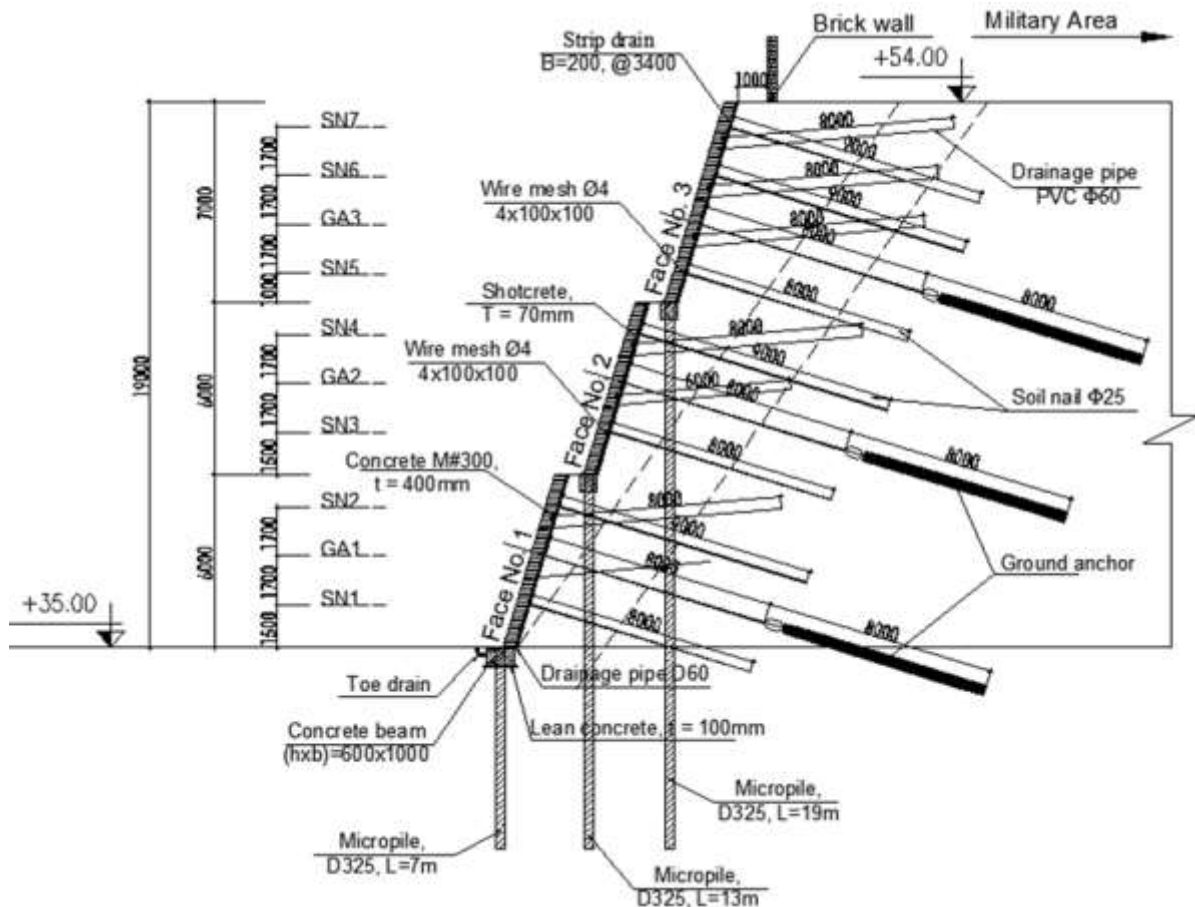
Figure 3. Details of reinforcing approach for slope located in section No.3, and No.4 (acc the locations presented in Figure 1).

micropiles of 325 mm diameter were suggested in the design proposal. The geometry of a cut slope was reengineered to achieve a slope angle equal to 1:0.3 inclination. The entire height of the slope was divided into subsections 6 m high each. The same inclination was proposed to all the sections. all have the same slope angle of 73°, thus the slope is considered extremely steep requiring enough geotechnical safety assurance. To support the structure and improve the ground conditions even more and also to allow more space (by increasing the inclination) as well as to execute the micropile work, two berms with of 1.00 m width were designed at the level of +41.00, and +47.00. Figure 3 presents the entire reinforcing system applied at the slope in sections 3 and 4, a similar approach was used in sections 1 and 2. Each of the sections is described in detail as follows: Slope's face No. 1 from the level of +35.00 to +41.00. This lowest face of the hill slope is

stabilized using two soil nail rows (nail diameter of 25 mm, length of the nail is 9.0 m); one ground anchor layer consisting of 8.0 m bond length and 8.0 free length, the designed force of the ground anchor layer is 250 kN. In order to prevent the general slope failure event, a row of micropile was proposed. The diameter and length of the micropile are 325 mm, 7.0 m, respectively. The face slope is consequently protected from infiltration water by using a concrete layer of 400 mm, with drainage layers behind the wall. Slope's face No. 2 (middle face slope) from the level of +41.00 to +47.00: This middle face of the hill slope is stabilized using two soil nail rows (nail diameter of 25 mm, length of nails are 8.0 m and 9.0 m); one ground anchor layer consists of 8.0 m bond length and 8.0 free length, the design force of ground anchor is 260 kN. A row of micropile is proposed of diameter and length of 325 mm, 13.0 m, respectively. The face slope is covered using a

concrete layer of 400 mm. Slope's face No. 3, starts from the level of +47.00. This face is stabilized using three soil nail rows, with a nail diameter of 25 mm and length of 8.0 m, 9.0 m and 9.0 m. One ground anchor layer consists of 8.0 m bond length and 8.0 free length, the design force of this ground anchor layer is 250 kN. A row of micropile 325 mm in diameter and 19 m long were proposed. The face slope as in previous sections is protected using a 400 mm concrete layer.

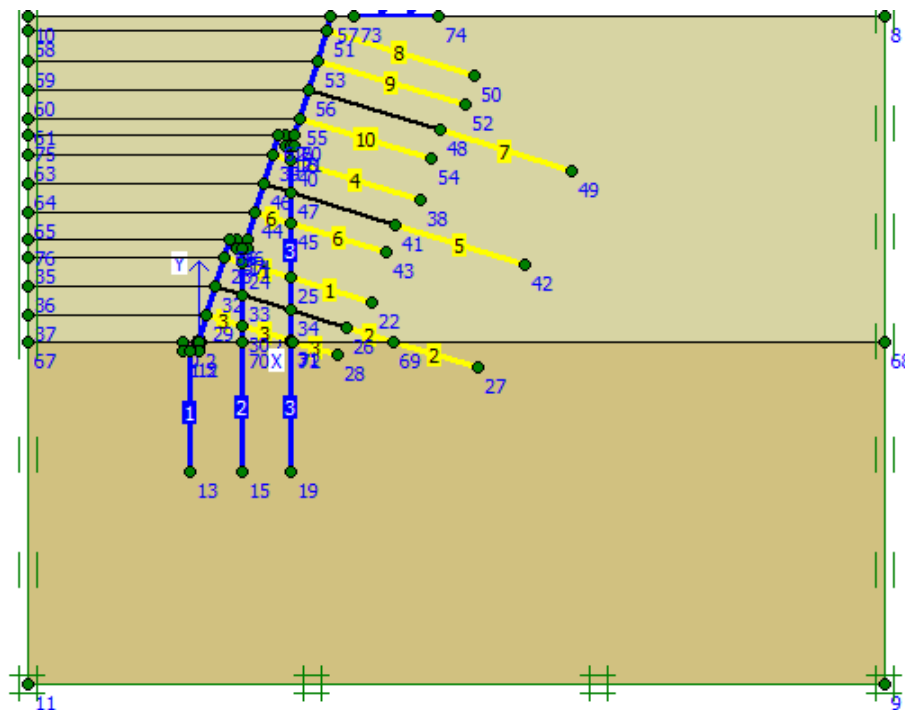
Figure 4. The typical numerical model calculation for the 3rd, 4th sections.

To calculate and evaluate the slope stability, the geotechnical software Plaxis 2D was employed (Brinkgreve, 2010). The geometry of the slope, reinforcing elements, berms, investigation ground conditions data were incorporated into the finite element model. The general view of the model with all its features is presented in Figure 4.

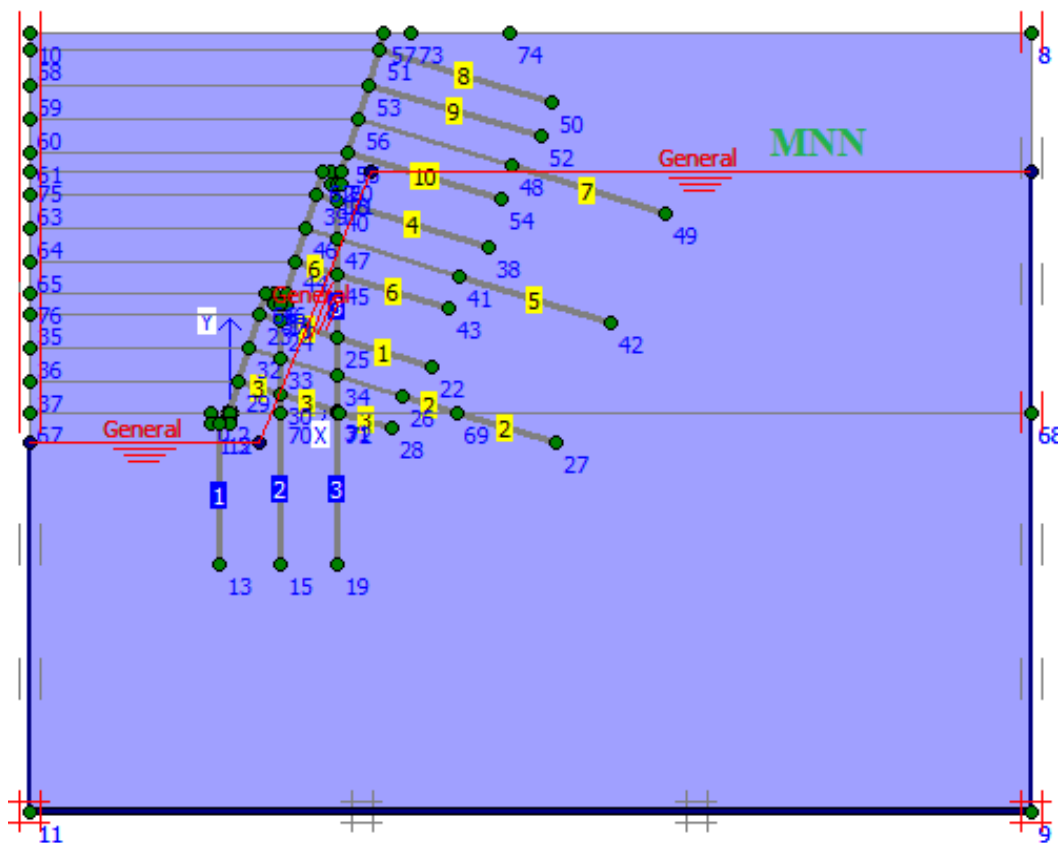
Figure 5. Changed groundwater table conditions.

In order to evaluate the long term performance of the slope, a worst-case scenario in which the groundwater table rises to a level of +47.00 was evaluated. The groundwater flow conditions are presented in Figure 5. The size of the model was made large enough in such a way that the boundary condition does not affect the computed results. The computation process took a total number of 22 steps. To make it easy to follow the steps of the procedure are listed in Table 2.

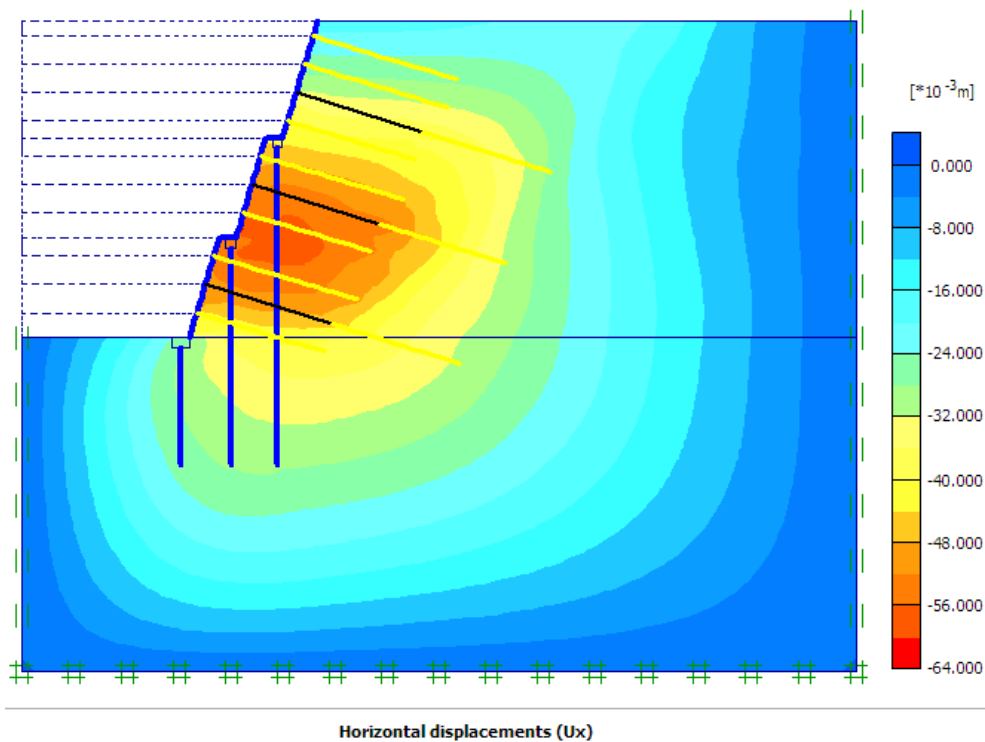
Figure 6. Distribution of lateral displacement of the in sections 3 and 4.

displacements and overall Factor of Safety (FS). The approach used for FS computation was shear strength reduction (Farshidfar et al., 2015). The method allows generating out-of-balance forces that are solved using a calculation kernel that results in deformation. These additional displacements that are generated do not have a physical meaning, but the incremental displacements or incremental shear strains in the final calculation step, indicate the likely failure mechanism. The computations were performed for all the sections described (Section No 1-4). According to (Peck, 1969), to restrain the strain level of the backfill and to maintain the stability of the retaining wall the wall displacements should be smaller than the value at the failure. The value at the failure is considered less than $H/60$ where H is the wall height. For the factor of safety higher than 2 the value becomes $H/150-200$. The maximum computed lateral displacement for Section No 1 and 2 found to fall in the acceptable range of $U_x = 37 \times 10^{-3} \text{ m} \sim 3.7 \text{ cm} < [\delta] = H/(150-200) = (7.8-10) \text{ cm}$ as recommended in (Peck, 1969), where $H = 15$ is the height of the slope. For section no 3 and 4 the computed displacements were significantly higher (by as much as 35%) but this is simply due to different slope geometry displacements, $U_x = 50 \times 10^{-3} \text{ m} \sim 5.0 \text{ cm} < [\delta] = H/(150-200) = 8.5-11.5 \text{ cm}$, where $H = 15$ is the height of the slope. The computation results for sections 3 and 4 are presented in Figure 6.

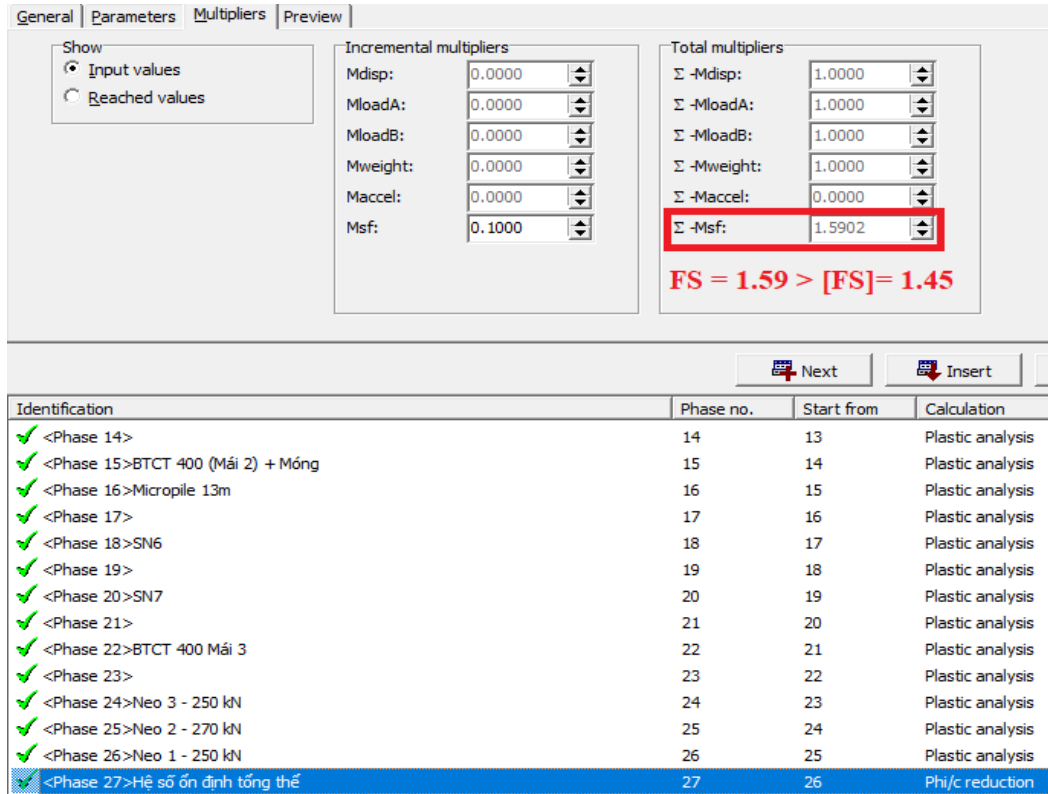
Figure 7. Overall stability analysis result of the proposed approach for sections 3 and 4.

The geotechnical safety computations also involved numerical analyses of the factor of safety. The results differ for each section but they all proved that the proposed solutions give satisfying FS falling in a range of 1.59 (sections 3 and 4) to 1.67 (sections 1 and 2). Adopting recommended FS value for high risk stricter being 1.45 the case study and the solution proposed could be considered as safe from a geotechnical point of view. The computation captured during the calculation process is presented in Figure 7.

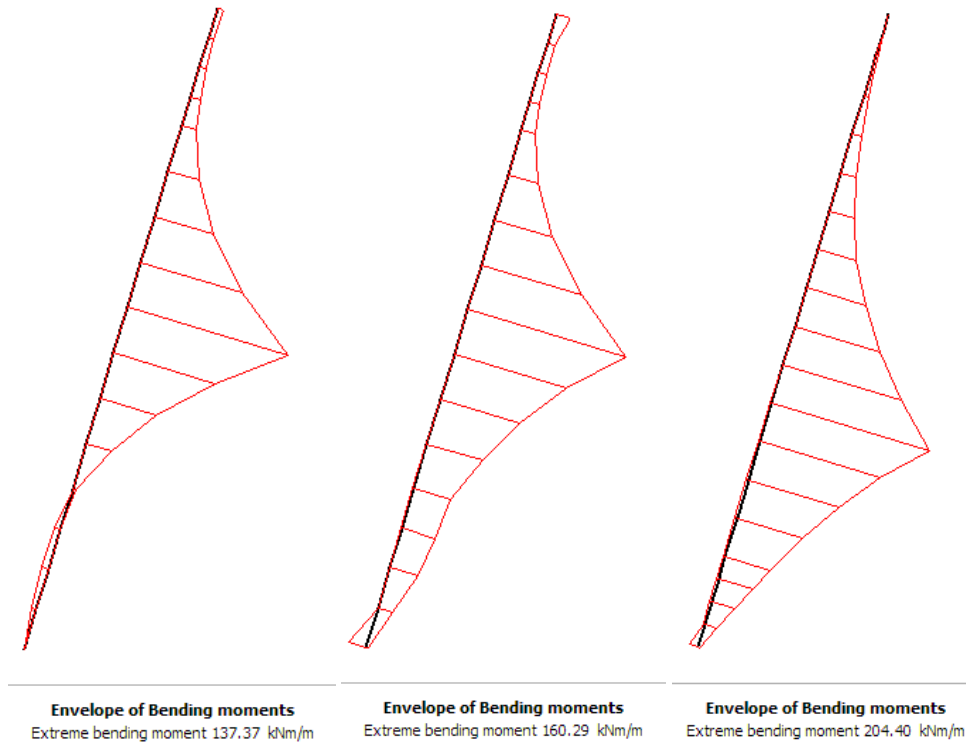
Figure 8. Slope's face bending moment distribution: a – Face No. 1 b – Face No. 2, c – Face No. 3.

Additional calculations were performed to verify bending moment distributions in each slopes' face (concrete 400mm layers). The example results for each facing (1, 2, 3) of sections 3 and 4 are shown in Figure 8. The extreme bending moments showed acceptable values ranging from 137.37 to 204.40 kNm/m.
