Analysis Instability of the Riverbank: A Case Study of Tien Riverbank in Cai Be district, Tien Giang Province, Vietnam

Tien riverbank in Cai Be district, Tien Giang province has quite a complex geological structure and human activities, so the riverbanks are frequently instability. The article refers to the instability of the Tien riverbank flowing through Cai Be district, Tien Giang Province. Based on the collected documents, analyzing remote sensing images, and field investigations, two types of riverbank instability with varying severity were identified. The main causes of instability are river flow erosion, influence of waves, geological factors, hydraulic pressure, sand depletion, and human activities. The selection of countermeasures against riverbank erosion in the study area should consider the soft soil ground structure along the riverbank, and the impact of horizontal waves caused by boat activities. Regarding the countermeasures for stability of riverbank, the method of pre-stressed piles exhibit a good solution against riverbank erosion. The research results are the basis for proposing effective prevention solutions to serve sustainable development along this river.

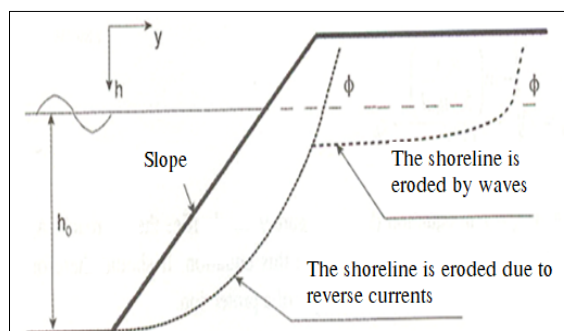
Fig. 13. Diagram analyzing some causes of bank erosion

There are 2 main causes of waves in this area:

- Waves caused by wind: waves in both the southwest and northeast monsoon seasons during high water periods are one of the causes of shore erosion. Especially, the wave influence during the monsoon season (Northeast season) causes landslides in the southern shore of the island.

- Waves caused by activities of boats: the density of boats operating on the river with high frequency and large capacity cargo ships, although not close to the shore, it still cause horizontal waves with heights ranging from $(0.3 \div 0,5)\text{m}$ which is the cause of bank erosion.

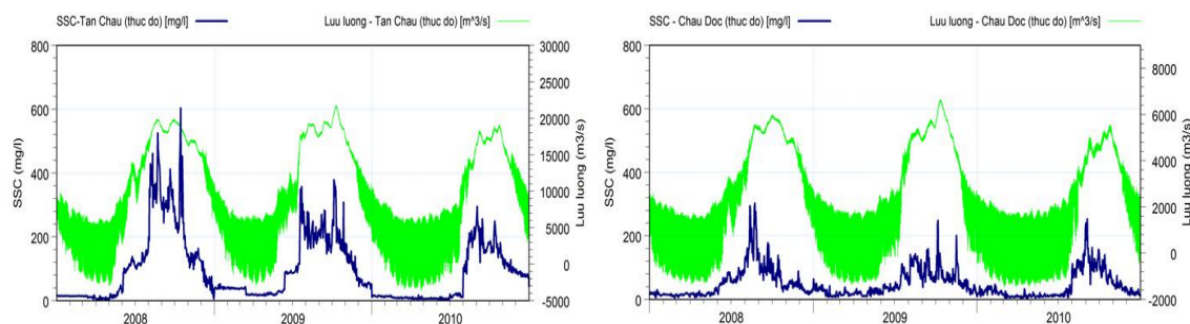
Fig.17. Flow process and suspended sediment content actually measured at Tan Chau station (left) and Chau Doc in the period 2008 - 2010 (Hung et al., 2013)

The distribution chart of suspended sand and sediment content at Tan Chau and Chau Doc stations (Fig. 17) shows clear seasonal fluctuations of sand and sediment on the main stream of the Mekong river. The concentration of suspended sand and sediment in Tan Chau during the flood season ranges from 200-500 mg/l and reaches the largest value during the flood peak, while in the dry season it is only about 30-100 mg/l. The concentration of suspended sand and sediment in Chau Doc during the flood season is much lower than that in Tan Chau, only from 100 ÷ 300 mg/l. The average total amount of sand and mud in the three years 2008 - 2010 at Tan Chau and Chau Doc stations is 46.2 and 5.6 million m³, respectively, equivalent to about 76.2 and 9.2 million tons (Hung et al., 2013).

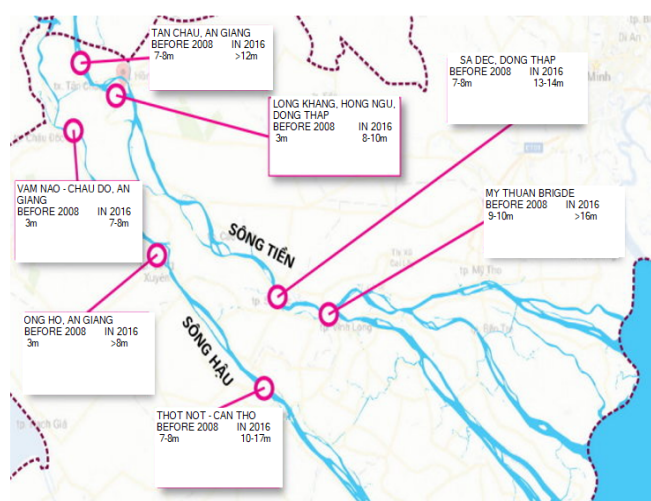
Fig.18. Diagram of some areas of the Tien and Hau rivers appearing deeper than before (Truong, 2016)

According to the Southern Inland Waterways Branch (Truong, 2016), the rate of deepening of the Tien and Hau rivers from 2008 to present has been faster, on average from 3-7 m. This situation occurs on the entire route, not just any section.
